Vulnerability Assessment of Buildings against Earthquake Case Study: Qadghoon Neighborhood, Borujerd, Iran

Original Article

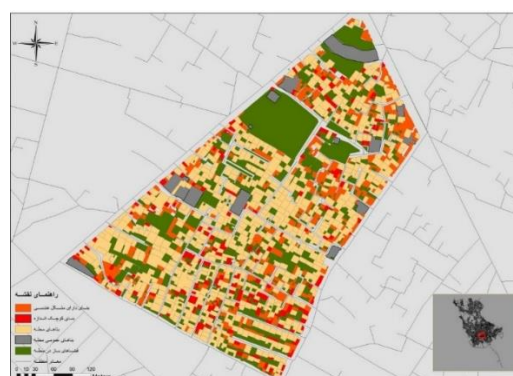
The assessment of these buildings was based on three maps, namely the existence of asymmetries in the plot plan, the frequency of asymmetries in the block, and different forms of public buildings. Figure 1 depicts two types of buildings which were found in great numbers in this neighborhood. One group was the buildings with severe inherent geometric problem (According to the index explanations, the buildings which have irregular vertical and

Figure 4. Locating buildings with geometric problems (authors)

horizontal dimensions and those that cannot tolerate the pass correction are considered geometrically irregular.) or that were problematic due to the corrections made after reconstruction processes, such as widening the carriageways. The second group consisted of small buildings, and consequently, of high vulnerability. Lack of geometric regularity and the smaller size (buildings with an area of lesser than 50 square meters including business and residential uses. See the table of extracted indexes.) of the building showed a complex seismic behavior that was much harder to be analyzed and predicted, compared to regular and simple buildings, which resulted in its higher vulnerability. On the other hand, these buildings confront the officials with greater difficulties (Due to the irregular structure which is in contrast with the regular structure of the reconstructed area and buildings, this issue causes an increase in the costs of the reconstruction process.) during the reconstruction process and cause a delay in reconstruction and a waste of resources.
