Vulnerability Assessment of Buildings against Earthquake Case Study: Qadghoon Neighborhood, Borujerd, Iran

Original Article

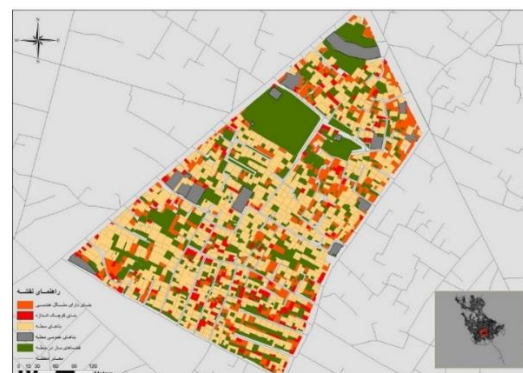
The assessment of these buildings was based on three maps, namely the existence of asymmetries in the plot plan, the frequency of asymmetries in the block, and different forms of public buildings. Figure 1 depicts two types of buildings which were found in great numbers in this neighborhood. One group was the buildings with severe inherent geometric problem (According to the index explanations, the buildings which have irregular vertical and

Figure 4. Locating buildings with geometric problems (authors)

horizontal dimensions and those that cannot tolerate the pass correction are considered geometrically irregular.) or that were problematic due to the corrections made after reconstruction processes, such as widening the carriageways. The second group consisted of small buildings, and consequently, of high vulnerability. Lack of geometric regularity and the smaller size (buildings with an area of lesser than 50 square meters including business and residential uses. See the table of extracted indexes.) of the building showed a complex seismic behavior that was much harder to be analyzed and predicted, compared to regular and simple buildings, which resulted in its higher vulnerability. On the other hand, these buildings confront the officials with greater difficulties (Due to the irregular structure which is in contrast with the regular structure of the reconstructed area and buildings, this issue causes an increase in the costs of the reconstruction process.) during the reconstruction process and cause a delay in reconstruction and a waste of resources.

30% of irregular and geometrically problematic buildings (respectively, 108 out of 154, 21 out of 35, 31 out of 156, 23 out of 42, 67 out of 149, 16 out of 37, and 3 out of 10) formed the next ranks of highly vulnerable buildings. Block 14, which was the green space, was analyzed as having the lowest rate of vulnerability in this index. Totally, out of 1,290 buildings in this neighborhood, 874 (68%) buildings had geometric asymmetries. This amount, which formed one-fifth of the whole number of buildings in this neighborhood, indicated that with a score of 4.5, the vulnerability was very high. Since different forms of public buildings perform different functions in different periods, it is important to investigate them from this point of view. According to Figure 4, 80% and 20% of public buildings have nuclear and linear forms, respectively. Although linear forms were more vulnerable during the earthquake, since the number of such buildings was less in the neighborhood, the rate of vulnerability decreased. Therefore, according to the abovementioned issue and the greater number of nuclear buildings, the vulnerability number of 3.2 can be considered as an average indicator.

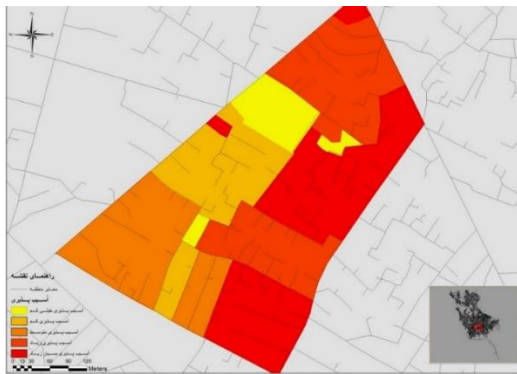
Figure 5. Location of blocks with irregular and unconventional buildings (authors)

Blocks with irregular buildings were also more

vulnerable during and after the earthquake and their reconstruction underwent greater delay. Figure 2 shows the percentage and number of irregular and unconventional buildings and categorizes the blocks based on this index. According to this figure, blocks number 13 and 1, with the highest frequency of more than 90% of the buildings, had the highest vulnerability. Among 109 buildings in block No. 1, 105 buildings were found asymmetric and unconventional and all the 4 buildings in block No. 13 were also asymmetric and irregular. Following that, blocks number 15, 10, 4, 3, and 2, had a great vulnerability with more than 80% of the irregular buildings, compared to all buildings in this neighborhood. In other words, block No. 2 with 137 buildings out of 171 buildings, block No. 3, with 4 buildings out of the total of 5, block No. 4 with 146 buildings out of 181, block No. 10 with 198 buildings out of 223, and block No. 15 with 11 buildings out of 13 were within this range of vulnerability. Block 12 with 70%, block 8 with 60%, block 6 with 56%, block 9 with 55%, block 5 with 45%, block 7 with 43%, and block 11 with

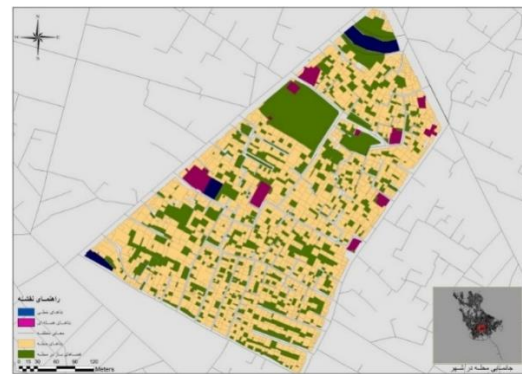
Figure 6. Locating various forms of public buildings (authors)

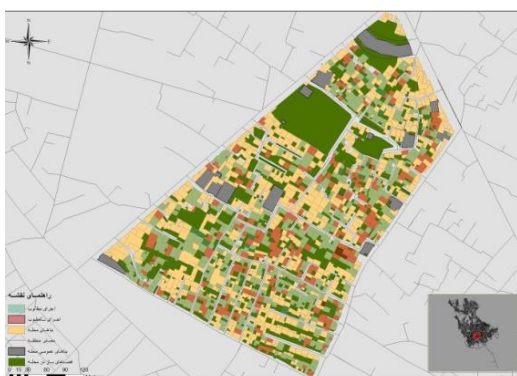
Figure 7. Locating of poorly constructed buildings (authors)

Weak construction remarkably enhances the amount of vulnerability during the earthquake. An increase in the number of losses and damages within the post-disaster time-span would double the amount of vulnerability. Figure 4 illustrates the buildings which were poorly reconstructed (the other hand, in addition to the present field

study, familiarity with construction conditions through life experience before the April 2006 earthquake in Borujerd and the presence of authors in this city, in the years after reconstruction and close observation of processes occurring, especially in the first years after the earthquake and the problems of this period, one of the most important of which was the lack of skilled and specialized personnel in the region, despite the high number of renovated buildings in this period, shows an intense decrease in the quality of construction in this period) after the earthquake due to several reasons, such as a lack of consistent and careful supervision of the reconstruction and/or an absence of expertise among the members of the reconstruction teams. These buildings incorporated 34% and 16% of the newly constructed and the total number of buildings in this area, respectively. Such statistics indicate the low-reliability coefficients of the newly constructed buildings and extensive waste of reconstruction budget. Overall, the vulnerability number in this index was obtained at 4, which was high.

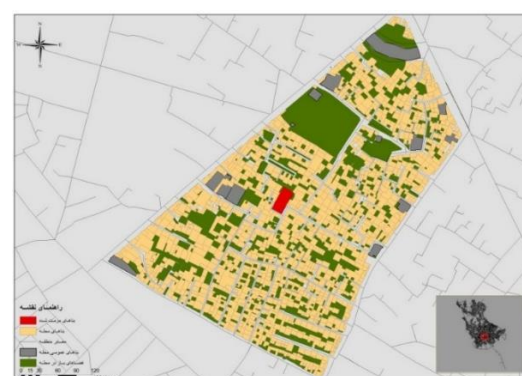
Figure 8. Locating restored building (authors)

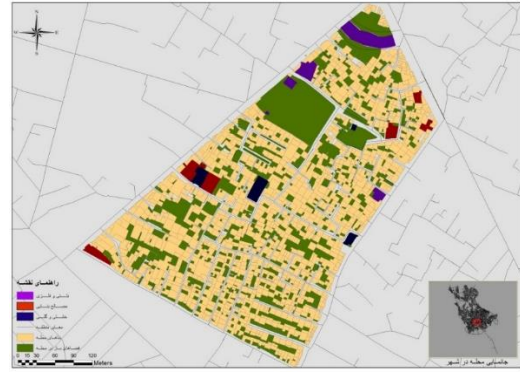
Figure 10. Locating types of construction technology (authors)

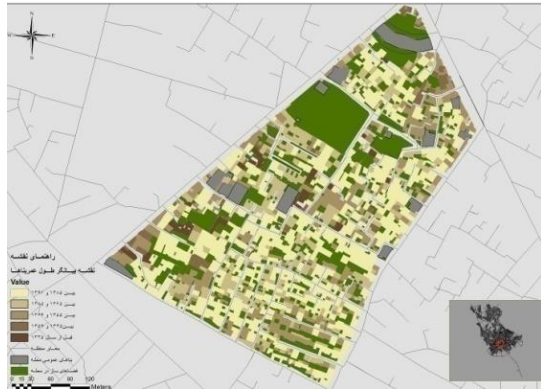
Figure 11. Longevity of the buildings (authors)

The long life of buildings can enhance the rate of vulnerability during the earthquake if they are not restored and reconstructed. Nevertheless, due to the scarce consistent technical supervision on the construction process of buildings before the earthquake, the buildings become even more vulnerable. This index not only increases the losses and damages rate within the area but also affects the vulnerability in the form of difficulties that might be experienced with regard to the consequent rescue and relief measures and the organization and reconstruction processes.

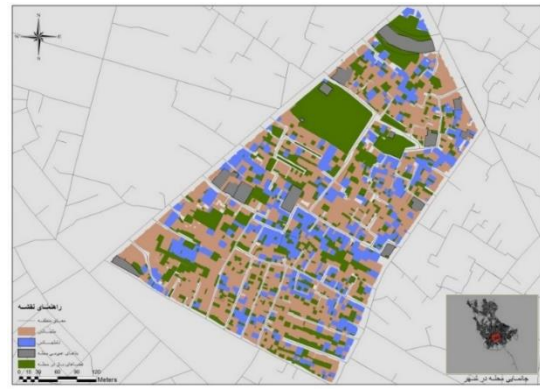
Figure 12. Locating incompatible buildings (authors)

The presence of this index during the crisis causes an increase in the vulnerability of the area and is influential on the intervals before and after the disaster. According to the Figure 12, 29.9% of the whole buildings are incompatibly constructed close to the vicinity of other buildings in that area.

Different factors can cause this incompatibility, including the excessive worn out status of the buildings and breakdowns, extra height compared to the vicinity, large size, and formal contradictions. This amount of incompatible buildings and the way that they are spread throughout the area indicate a high vulnerability index reflected by the vulnerability number of 4.
