Vulnerability Assessment of Buildings against Earthquake Case Study: Qadghoon Neighborhood, Borujerd, Iran

Original Article

Keywords: Borujerd; Earthquake; Qadghoon Neighborhood; Single-scale of Building; Vulnerability Assessment.

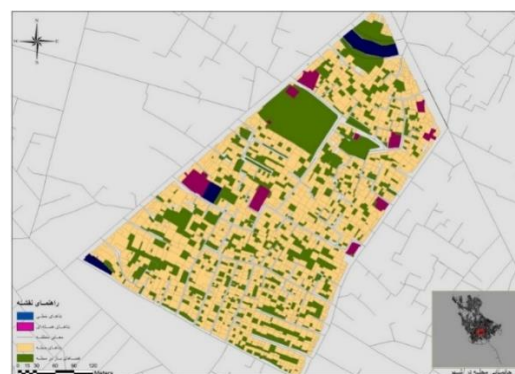
Figure 6. Locating various forms of public buildings (authors)

Overall, the total vulnerability number of this index was considered high (4 out of 5) due to the frequency of irregular and different forms of public buildings.

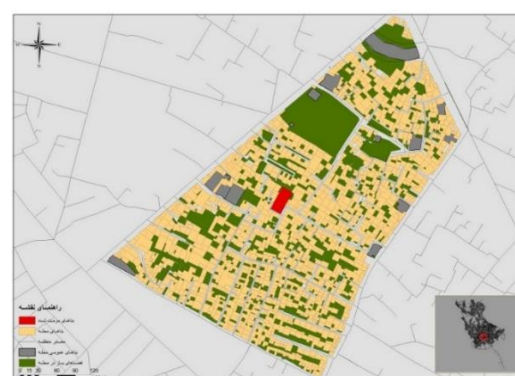
Figure 8. Locating restored building (authors)

Along with the preservation of the heritage and identity of the land, restoration of historically valuable buildings would decrease the vulnerability of the area during the disaster. Additionally, protecting these buildings via restoration would increase the possibilities of future developments by tourism enhancement and plays a highly direct role in controlling poverty within the area. Although extensive restorations have been carried out during the reconstruction of the area, Figure 4 shows that 5% of the whole buildings in this area

are made of brick (with a frequency of 64 buildings), most of which have architectural and identity values. Since only one out of all buildings was restored (See the zoning map of the restoration of the area or the locating of the restored buildings), the vulnerability number was estimated at 5, which was very high.

- From the perspective of the Cultural Heritage Preservation Index, out of 64 former brick buildings in the neighborhood, only one historic house was restored, and other buildings had either been destroyed or abandoned during the post-disaster reconstruction and were in danger of being demolished.

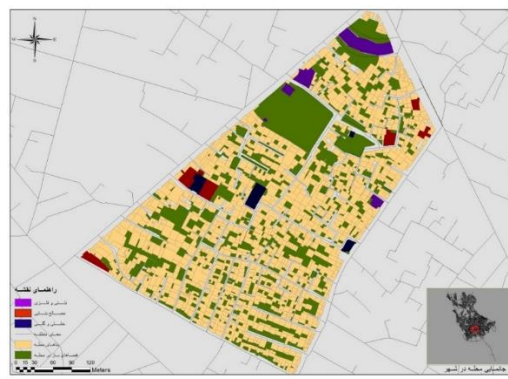
Figure 10. Locating types of construction technology (authors)

The effect of the high vulnerability score of public buildings is more obvious in different stages of the earthquake especially the post-disaster stage. In this area, 33% of the whole public buildings were made of concrete and metal structures, and therefore, had low vulnerability against the earthquake. However, the structures made of building materials with a frequency of 40% had the highest score among the public buildings. Moreover, 27% of the public buildings were made of brick, indicating a very high vulnerability index. These buildings should be restored and reconstructed before the occurrence of other disasters. The score of vulnerability in this respect was estimated at 3.61, which was average to relatively high. Overall, the

vulnerability score obtained for the types of construction of buildings (private and public) was 3.6, which was average to relatively high.
