## Vulnerability Assessment of Buildings against Earthquake Case Study: Qadghoon Neighborhood, Borujerd, Iran

### Original Article

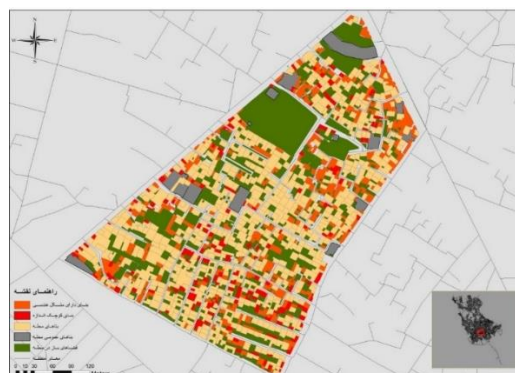
**Figure 4.** Locating buildings with geometric problems (authors)

The assessment of these buildings was based on three maps, namely the existence of asymmetries in the plot plan, the frequency of asymmetries in the block, and different forms of public buildings. Figure 1 depicts two types of buildings which were found in great numbers in this neighborhood. One group was the buildings with severe inherent geometric problem (According to the index explanations, the buildings which have irregular vertical and

horizontal dimensions and those that cannot tolerate the pass correction are considered geometrically irregular.) or that were problematic due to the corrections made after reconstruction processes, such as widening the carriageways. The second group consisted of small buildings, and consequently, of high vulnerability. Lack of geometric regularity and the smaller size (buildings with an area of lesser than 50 square meters including business and residential uses. See the table of extracted indexes.) of the building showed a complex seismic behavior that was much harder to be analyzed and predicted, compared to regular and simple buildings, which resulted in its higher vulnerability. On the other hand, these buildings confront the officials with greater difficulties (Due to the irregular structure which is in contrast with the regular structure of the reconstructed area and buildings, this issue causes an increase in the costs of the reconstruction process.) during the reconstruction process and cause a delay in reconstruction and a waste of resources.

30% of irregular and geometrically problematic buildings (respectively, 108 out of 154, 21 out of 35, 31 out of 156, 23 out of 42, 67 out of 149, 16 out of 37, and 3 out of 10) formed the next ranks of highly vulnerable buildings. Block 14, which was the green space, was analyzed as having the lowest rate of vulnerability in this index. Totally, out of 1,290 buildings in this neighborhood, 874 (68%) buildings had geometric asymmetries. This amount, which formed one-fifth of the whole number of buildings in this neighborhood, indicated that with a score of 4.5, the vulnerability was very high. Since different forms of public buildings perform different functions in different periods, it is important to investigate them from this point of view. According to Figure 4, 80% and 20% of public buildings have nuclear and linear forms, respectively. Although linear forms were more vulnerable during the earthquake, since the number of such buildings was less in the neighborhood, the rate of vulnerability decreased. Therefore, according to the abovementioned issue and the greater number of nuclear buildings, the vulnerability number of 3.2 can be considered as an average indicator.

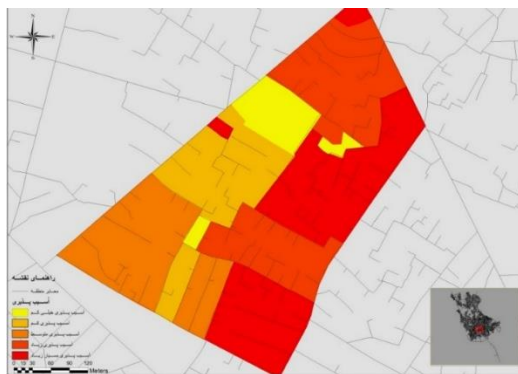
**Figure 5.** Location of blocks with irregular and unconventional buildings (authors)

Blocks with irregular buildings were also more

vulnerable during and after the earthquake and their reconstruction underwent greater delay. Figure 2 shows the percentage and number of irregular and unconventional buildings and categorizes the blocks based on this index. According to this figure, blocks number 13 and 1, with the highest frequency of more than 90% of the buildings, had the highest vulnerability. Among 109 buildings in block No. 1, 105 buildings were found asymmetric and unconventional and all the 4 buildings in block No. 13 were also asymmetric and irregular. Following that, blocks number 15, 10, 4, 3, and 2, had a great vulnerability with more than 80% of the irregular buildings, compared to all buildings in this neighborhood. In other words, block No. 2 with 137 buildings out of 171 buildings, block No. 3, with 4 buildings out of the total of 5, block No. 4 with 146 buildings out of 181, block No. 10 with 198 buildings out of 223, and block No. 15 with 11 buildings out of 13 were within this range of vulnerability. Block 12 with 70%, block 8 with 60%, block 6 with 56%, block 9 with 55%, block 5 with 45%, block 7 with 43%, and block 11 with

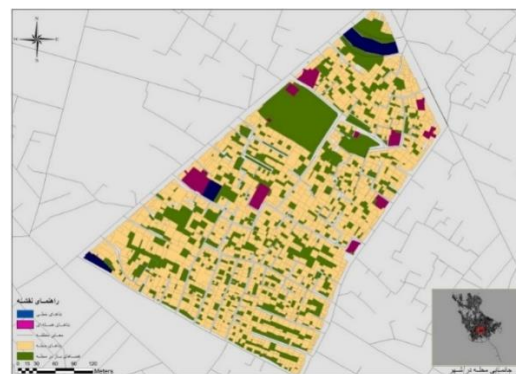
**Figure 6.** Locating various forms of public buildings (authors)

Overall, the total vulnerability number of this index was considered high (4 out of 5) due to the frequency of irregular and different forms of public buildings.

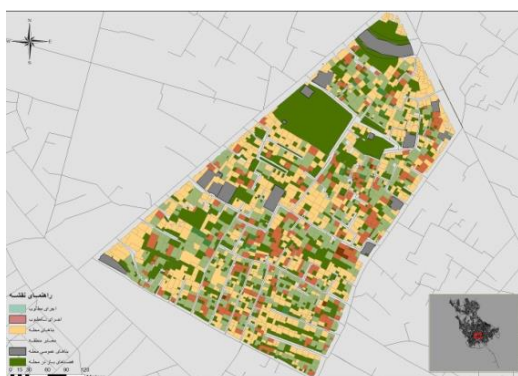
**Figure 7.** Locating of poorly constructed buildings (authors)

Weak construction remarkably enhances the amount of vulnerability during the earthquake. An increase in the number of losses and damages within the post-disaster time-span would double the amount of vulnerability. Figure 4 illustrates the buildings which were poorly reconstructed (the other hand, in addition to the present field

study, familiarity with construction conditions through life experience before the April 2006 earthquake in Borujerd and the presence of authors in this city, in the years after reconstruction and close observation of processes occurring, especially in the first years after the earthquake and the problems of this period, one of the most important of which was the lack of skilled and specialized personnel in the region, despite the high number of renovated buildings in this period, shows an intense decrease in the quality of construction in this period) after the earthquake due to several reasons, such as a lack of consistent and careful supervision of the reconstruction and/or an absence of expertise among the members of the reconstruction teams. These buildings incorporated 34% and 16% of the newly constructed and the total number of buildings in this area, respectively. Such statistics indicate the low-reliability coefficients of the newly constructed buildings and extensive waste of reconstruction budget. Overall, the vulnerability number in this index was obtained at 4, which was high.

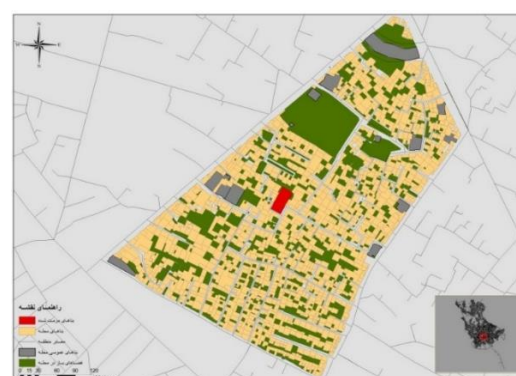
**Figure 8.** Locating restored building (authors)

Along with the preservation of the heritage and identity of the land, restoration of historically valuable buildings would decrease the vulnerability of the area during the disaster. Additionally, protecting these buildings via restoration would increase the possibilities of future developments by tourism enhancement and plays a highly direct role in controlling poverty within the area. Although extensive restorations have been carried out during the reconstruction of the area, Figure 4 shows that 5% of the whole buildings in this area

are made of brick (with a frequency of 64 buildings), most of which have architectural and identity values. Since only one out of all buildings was restored (See the zoning map of the restoration of the area or the locating of the restored buildings), the vulnerability number was estimated at 5, which was very high.

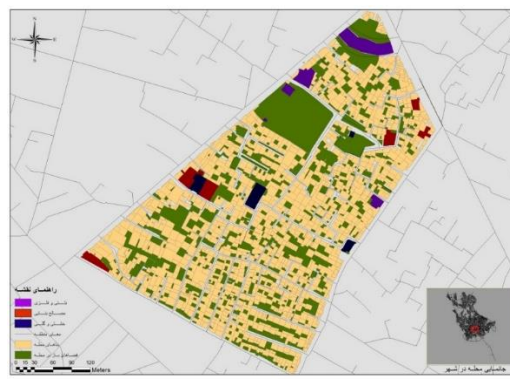
**Figure 10.** Locating types of construction technology (authors)

The effect of the high vulnerability score of public buildings is more obvious in different stages of the earthquake especially the post-disaster stage. In this area, 33% of the whole public buildings were made of concrete and metal structures, and therefore, had low vulnerability against the earthquake. However, the structures made of building materials with a frequency of 40% had the highest score among the public buildings. Moreover, 27% of the public buildings were made of brick, indicating a very high vulnerability index. These buildings should be restored and reconstructed before the occurrence of other disasters. The score of vulnerability in this respect was estimated at 3.61, which was average to relatively high. Overall, the

vulnerability score obtained for the types of construction of buildings (private and public) was 3.6, which was average to relatively high.

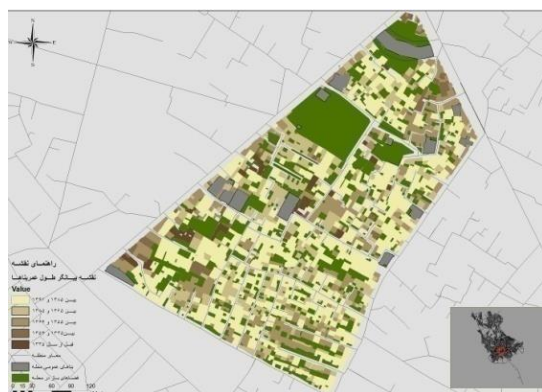
Figure 11. Longevity of the buildings (authors)

The long life of buildings can enhance the rate of vulnerability during the earthquake if they are not restored and reconstructed. Nevertheless, due to the scarce consistent technical supervision on the construction process of buildings before the earthquake, the buildings become even more vulnerable. This index not only increases the losses and damages rate within the area but also affects the vulnerability in the form of difficulties that might be experienced with regard to the consequent rescue and relief measures and the organization and reconstruction processes.

In this area, the buildings constructed after the earthquake, from 1976-85, and from 1986-2006 (i.e., before the earthquake) were rated in descending order with 45%, 25%, and 24% frequency of the whole buildings. The buildings constructed before 1976, however, were placed last in this ranking order with a low frequency of 6%. The statistics indicated the high rate of reconstruction and destruction, which were worthy of consideration in its due time. It can be concluded that with 55% of the buildings being constructed before the earthquake, the vulnerability level of the neighborhood was average to rather high with a score of 3.28.

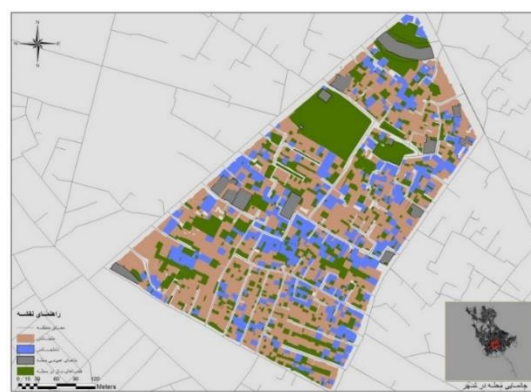
Figure 12. Locating incompatible buildings (authors)

The presence of this index during the crisis causes an increase in the vulnerability of the area and is influential on the intervals before and after the disaster. According to the Figure 12, 29.9% of the whole buildings are incompatibly constructed close to the vicinity of other buildings in that area.

Different factors can cause this incompatibility, including the excessive worn out status of the buildings and breakdowns, extra height compared to the vicinity, large size, and formal contradictions. This amount of incompatible buildings and the way that they are spread throughout the area indicate a high vulnerability index reflected by the vulnerability number of 4.
