Vulnerability Assessment of Buildings against Earthquake Case Study: Qadghoon Neighborhood, Borujerd, Iran

Original Article

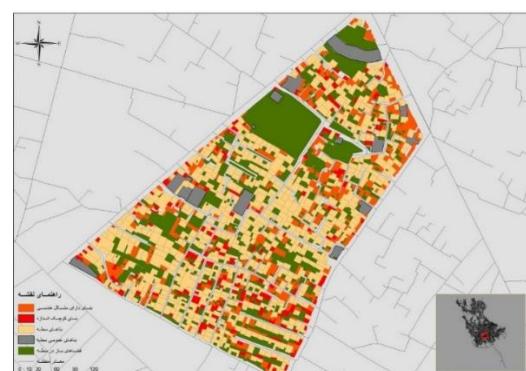
Figure 4. Locating buildings with geometric problems (authors)

The assessment of these buildings was based on three maps, namely the existence of asymmetries in the plot plan, the frequency of asymmetries in the block, and different forms of public buildings. Figure 1 depicts two types of buildings which were found in great numbers in this neighborhood. One group was the buildings with severe inherent geometric problem (According to the index explanations, the buildings which have irregular vertical and

horizontal dimensions and those that cannot tolerate the pass correction are considered geometrically irregular.) or that were problematic due to the corrections made after reconstruction processes, such as widening the carriageways. The second group consisted of small buildings, and consequently, of high vulnerability. Lack of geometric regularity and the smaller size (buildings with an area of lesser than 50 square meters including business and residential uses. See the table of extracted indexes.) of the building showed a complex seismic behavior that was much harder to be analyzed and predicted, compared to regular and simple buildings, which resulted in its higher vulnerability. On the other hand, these buildings confront the officials with greater difficulties (Due to the irregular structure which is in contrast with the regular structure of the reconstructed area and buildings, this issue causes an increase in the costs of the reconstruction process.) during the reconstruction process and cause a delay in reconstruction and a waste of resources.

30% of irregular and geometrically problematic buildings (respectively, 108 out of 154, 21 out of 35, 31 out of 156, 23 out of 42, 67 out of 149, 16 out of 37, and 3 out of 10) formed the next ranks of highly vulnerable buildings. Block 14, which was the green space, was analyzed as having the lowest rate of vulnerability in this index. Totally, out of 1,290 buildings in this neighborhood, 874 (68%) buildings had geometric asymmetries. This amount, which formed one-fifth of the whole number of buildings in this neighborhood, indicated that with a score of 4.5, the vulnerability was very high. Since different forms of public buildings perform different functions in different periods, it is important to investigate them from this point of view. According to Figure 4, 80% and 20% of public buildings have nuclear and linear forms, respectively. Although linear forms were more vulnerable during the earthquake, since the number of such buildings was less in the neighborhood, the rate of vulnerability decreased. Therefore, according to the abovementioned issue and the greater number of nuclear buildings, the vulnerability number of 3.2 can be considered as an average indicator.

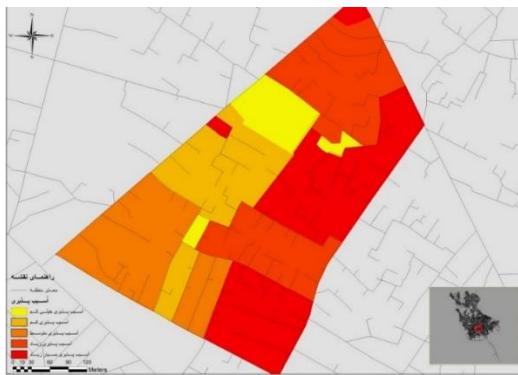
Figure 5. Location of blocks with irregular and unconventional buildings (authors)

vulnerable during and after the earthquake and their reconstruction underwent greater delay. Figure 2 shows the percentage and number of irregular and unconventional buildings and categorizes the blocks based on this index. According to this figure, blocks number 13 and 1, with the highest frequency of more than 90% of the buildings, had the highest vulnerability. Among 109 buildings in block No. 1, 105 buildings were found asymmetric and unconventional and all the 4 buildings in block No. 13 were also asymmetric and irregular. Following that, blocks number 15, 10, 4, 3, and 2, had a great vulnerability with more than 80% of the irregular buildings, compared to all buildings in this neighborhood. In other words, block No. 2 with 137 buildings out of 171 buildings, block No. 3, with 4 buildings out of the total of 5, block No. 4 with 146 buildings out of 181, block No. 10 with 198 buildings out of 223, and block No. 15 with 11 buildings out of 13 were within this range of vulnerability. Block 12 with 70%, block 8 with 60%, block 6 with 56%, block 9 with 55%, block 5 with 45%, block 7 with 43%, and block 11 with

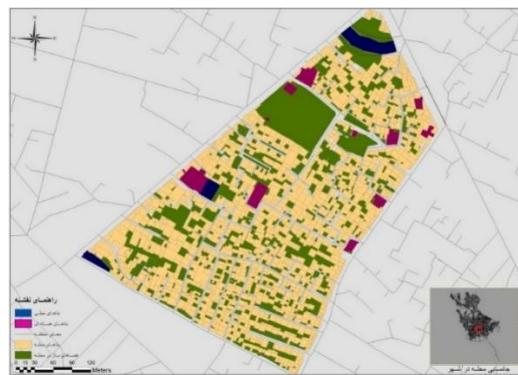
Figure 6. Locating various forms of public buildings (authors)

Overall, the total vulnerability number of this index was considered high (4 out of 5) due to the frequency of irregular and different forms of public buildings.

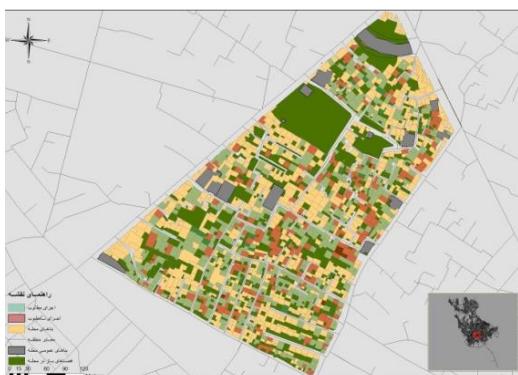
Figure 7. Locating of poorly constructed buildings (authors)

Weak construction remarkably enhances the amount of vulnerability during the earthquake. An increase in the number of losses and damages within the post-disaster time-span would double the amount of vulnerability. Figure 4 illustrates the buildings which were poorly reconstructed (the other hand, in addition to the present field

study, familiarity with construction conditions through life experience before the April 2006 earthquake in Borujerd and the presence of authors in this city, in the years after reconstruction and close observation of processes occurring, especially in the first years after the earthquake and the problems of this period, one of the most important of which was the lack of skilled and specialized personnel in the region, despite the high number of renovated buildings in this period, shows an intense decrease in the quality of construction in this period) after the earthquake due to several reasons, such as a lack of consistent and careful supervision of the reconstruction and/or an absence of expertise among the members of the reconstruction teams. These buildings incorporated 34% and 16% of the newly constructed and the total number of buildings in this area, respectively. Such statistics indicate the low-reliability coefficients of the newly constructed buildings and extensive waste of reconstruction budget. Overall, the vulnerability number in this index was obtained at 4, which was high.

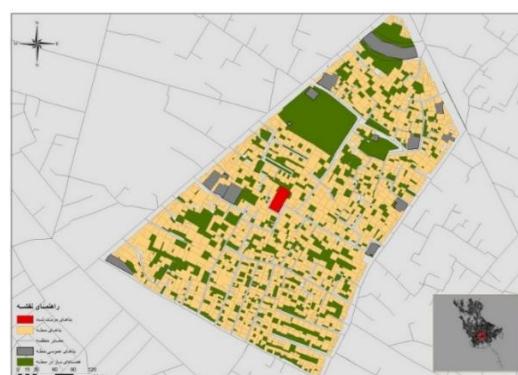
Figure 8. Locating restored building (authors)

Along with the preservation of the heritage and identity of the land, restoration of historically valuable buildings would decrease the vulnerability of the area during the disaster. Additionally, protecting these buildings via restoration would increase the possibilities of future developments by tourism enhancement and plays a highly direct role in controlling poverty within the area. Although extensive restorations have been carried out during the reconstruction of the area, Figure 4 shows that 5% of the whole buildings in this area

are made of brick (with a frequency of 64 buildings), most of which have architectural and identity values. Since only one out of all buildings was restored (See the zoning map of the restoration of the area or the locating of the restored buildings), the vulnerability number was estimated at 5, which was very high.

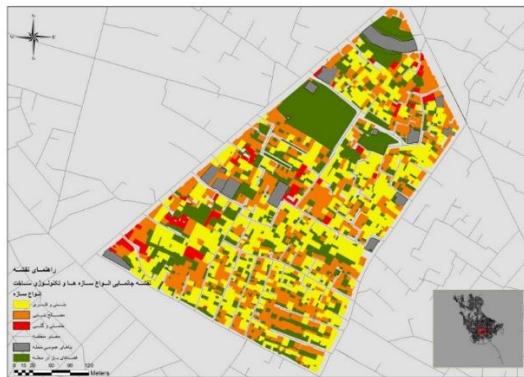
Figure 9. Types of construction and technology (authors)

The score of this index was extracted from two maps of private and public buildings of the area. If the vulnerability of the structures of the buildings within the area decreased, fewer losses would be experienced during the disaster. That is why it is believed that this index has a higher influence on vulnerability at the time of disaster. Based on the investigations of the area, the highest frequency of the type of construction materials was obtained for construction materials with 49%, followed by concrete and metal structures with 46% of the whole buildings. The least frequent structures were related to the traditional structures made of bricks with a 5% frequency. Since those structures constructed with building materials were not restored and did not perform well during the seismic shocks, along with the high number of poorly constructed (See the map of locating the poorly constructed new buildings) new buildings and also brick structures that were not restored (See the zoning map of the area restoration or the locating of restored buildings), the vulnerability score of the neighborhood in this respect was calculated at 3.59, which was considered average to a relatively high rate.

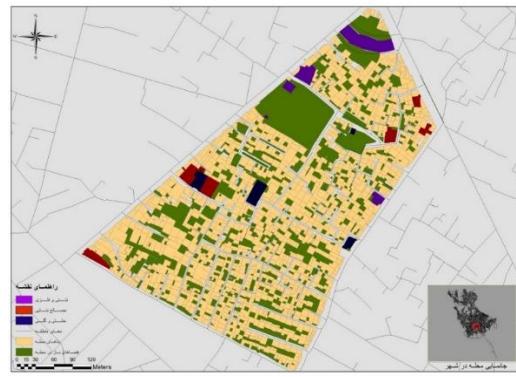
Figure 10. Locating types of construction technology (authors)

The effect of the high vulnerability score of public buildings is more obvious in different stages of the earthquake especially the post-disaster stage. In this area, 33% of the whole public buildings were made of concrete and metal structures, and therefore, had low vulnerability against the earthquake. However, the structures made of building materials with a frequency of 40% had the highest score among the public buildings. Moreover, 27% of the public buildings were made of brick, indicating a very high vulnerability index. These buildings should be restored and reconstructed before the occurrence of other disasters. The score of vulnerability in this respect was estimated at 3.61, which was average to relatively high. Overall, the

vulnerability score obtained for the types of construction of buildings (private and public) was 3.6, which was average to relatively high.

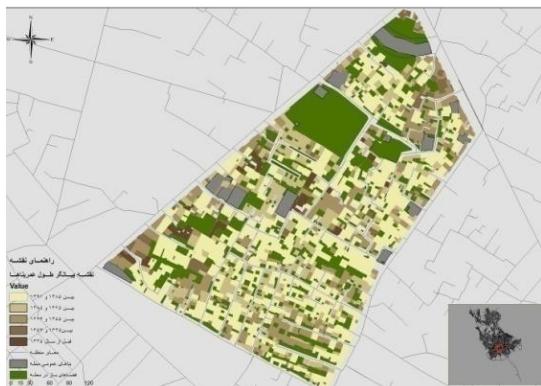
Figure 11. Longevity of the buildings (authors)

The long life of buildings can enhance the rate of vulnerability during the earthquake if they are not restored and reconstructed. Nevertheless, due to the scarce consistent technical supervision on the construction process of buildings before the earthquake, the buildings become even more vulnerable. This index not only increases the losses and damages rate within the area but also affects the vulnerability in the form of difficulties that might be experienced with regard to the consequent rescue and relief measures and the organization and reconstruction processes.

In this area, the buildings constructed after the earthquake, from 1976-85, and from 1986-2006 (i.e., before the earthquake) were rated in descending order with 45%, 25%, and 24% frequency of the whole buildings. The buildings constructed before 1976, however, were placed last in this ranking order with a low frequency of 6%. The statistics indicated the high rate of reconstruction and destruction, which were worthy of consideration in its due time. It can be concluded that with 55% of the buildings being constructed before the earthquake, the vulnerability level of the neighborhood was average to rather high with a score of 3.28.

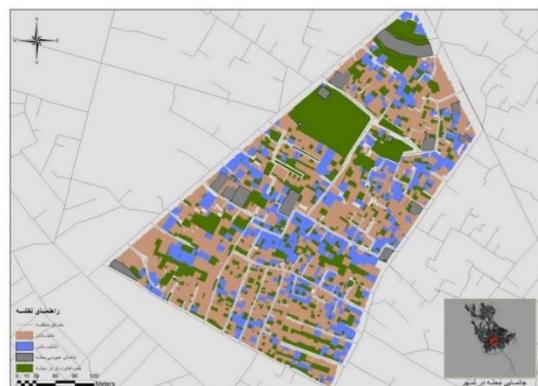
Figure 12. Locating incompatible buildings (authors)

The presence of this index during the crisis causes an increase in the vulnerability of the area and is influential on the intervals before and after the disaster. According to the Figure 12, 29.9% of the whole buildings are incompatibly constructed close to the vicinity of other buildings in that area.

Different factors can cause this incompatibility, including the excessive worn out status of the buildings and breakdowns, extra height compared to the vicinity, large size, and formal contradictions. This amount of incompatible buildings and the way that they are spread throughout the area indicate a high vulnerability index reflected by the vulnerability number of 4.
